ASRL TR 94-1

# TENSILE DEFORMATION AND FRACTURE OF BRAZED JOINTS

MASSACHUSETTS INSTITUTE OF TECHNOLOGY  
AEROELASTIC AND STRUCTURES RESEARCH LABORATORY  
DEPARTMENT OF AERONAUTICS AND ASTRONAUTICS

September 1961

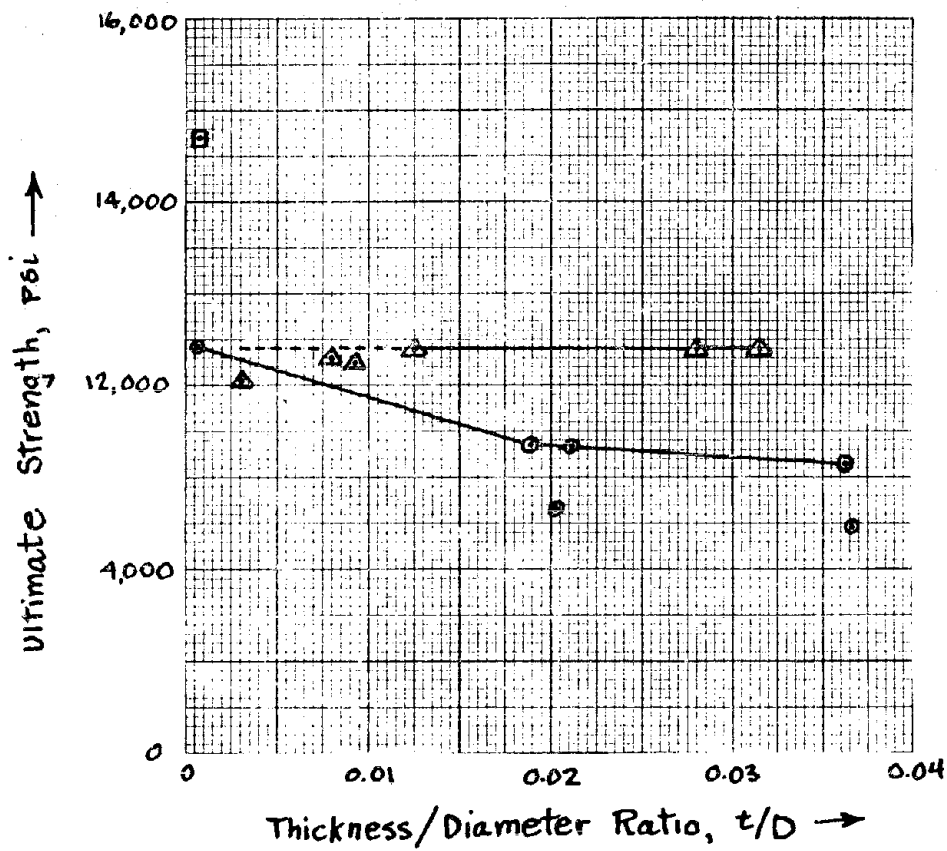
Figure 1. Strength of Lead Joints in Steel, Copper and Molybdenum

**LEAD JOINTS** Lead joints (containing 0.1% nickel) were made in steel, copper, and arc-cast molybdenum. Data are shown in Fig. 1; 0.009" joints in steel were, for the most part, quite sound, but only a single sound specimen was obtained from a

block brazed with no spacers in which the resulting joint thickness was 0.003". Tensile strengths of sound joints in steel lay in the range 6000-9000 psi; the tensile strength of the lead joints in copper were essentially constant and lay in the range 8100-8800 psi irrespective of t/D ratio. Attempts to produce a sound lead joint in molybdenum were not successful; a reasonably sound single specimen containing a few small non-wetted regions exhibited a strength of 13,400 psi. An additional series of lead joints in nickel base stock were attempted, for the purpose of examining the effect of base metal yield strength for two different materials having the same value of Young's Modulus (steel and nickel). These joints were not successful on the whole, but a single completely sound tensile specimen removed from one block exhibited a strength of 8500 psi at a t/D ratio of 0.002 (joint thickness: 0.0005", specimen diameter: 0.250". All of the fractured lead joints exhibited a pronounced crater formation on the fracture surface; detailed examination of the fracture surface indicated that a hemispherical cavity existed at corresponding points on both fracture surfaces. Fig. 2 shows matching faces of the fracture surface of a lead joint in steel; the surfaces were photographed with low angle illumination, and the shadows delineate the matching cavities on both faces.

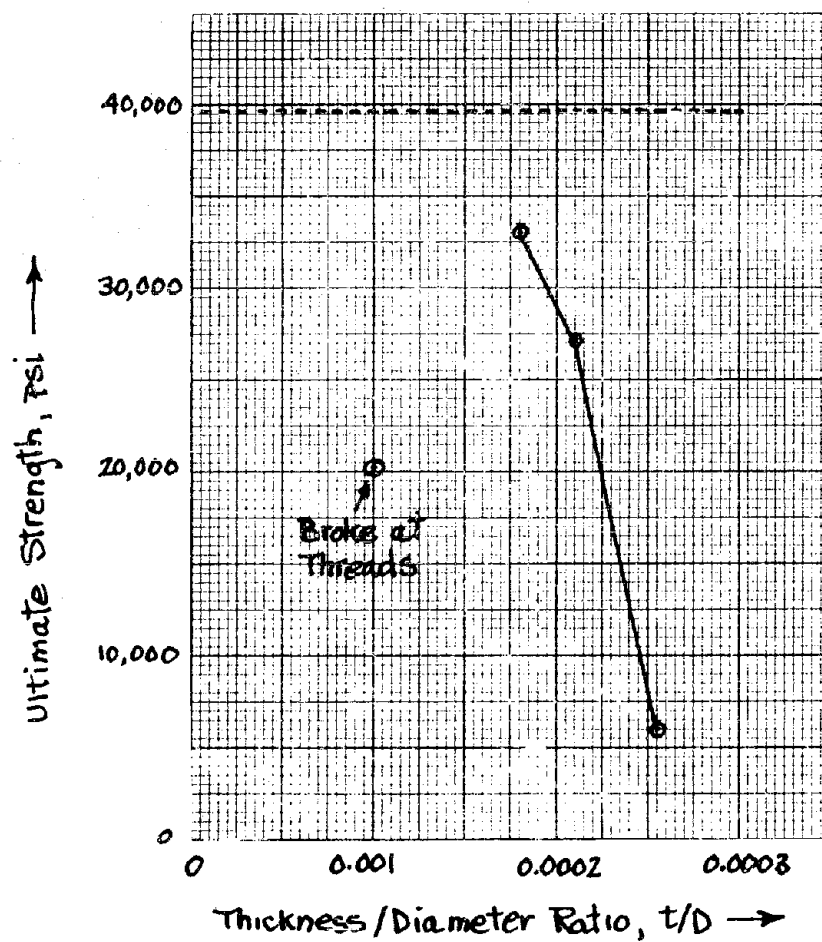
Figure 3. Strength of Tin Joints in Molybdenum: Joint Thickness = 0.0004"

TIN JOINTS A single block of arc-cast molybdenum having essentially zero ductility was made with a tin joint, for the purpose of examining the effect of a high-modulus, low-ductility base stock on a low-modulus, high-ductility filler metal. Fig. 3 shows the data for these specimens.
