# Silver/Glass Mirrors for Solar Thermal Systems

SERI/SP-271-2293

June 1985

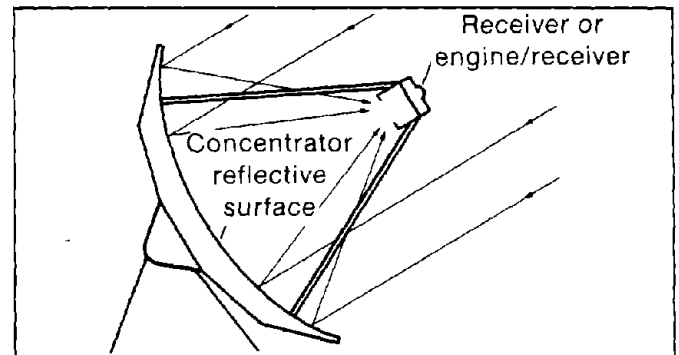
Figure 1-2 Parabolic Dish

Solar thermal mirrors are used in parabolic troughs, parabolic dishes, spherical bowls, and heliostats. The parabolic trough (Figure 1-1) concentrates the sun's rays along a line. The parabolic dish (Figure 1-2) concentrates the sun's rays toward a point. The spherical bowl (Figure 1-3) concentrates light along a rod. The compound parabolic concentrator (Figure 1-4) funnels light from a large aperture into a smaller receiver. The heliostat field employs a vast number of reflectors (flat or minimally parabolic) to focus on a central receiver, as shown in Figure 1-5.

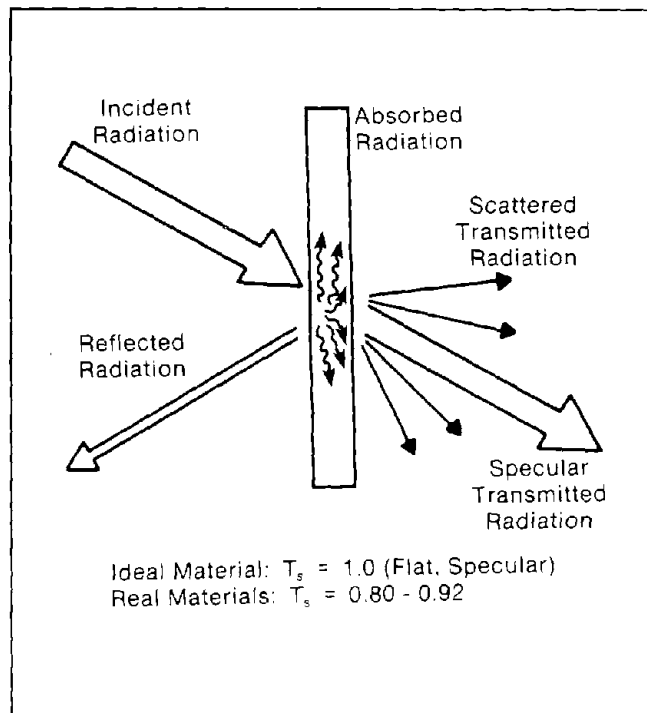
Figure 2-1 Optical Properties of Transmitters (Lind 1981)

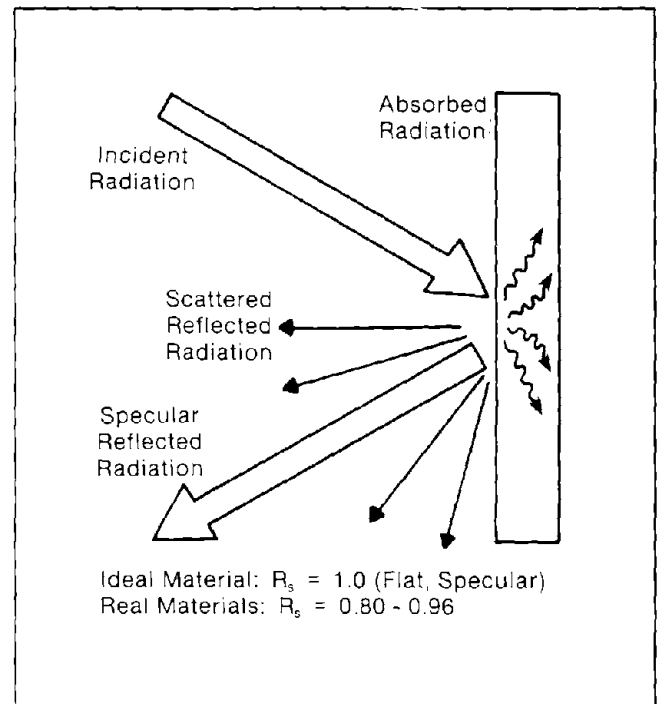
Figure 2-2 Optical Properties of Reflectors (Lind 1981)

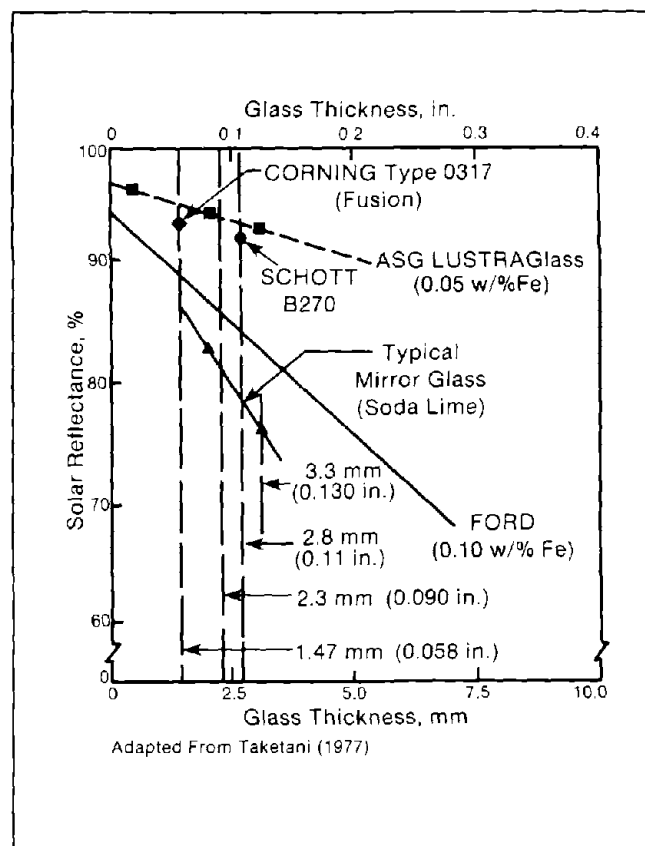
Figure 2-3 Solar Reflectance versus Glass Thickness for Typical Types of Second-Surface Glass Mirrors (Bouquet 1980)

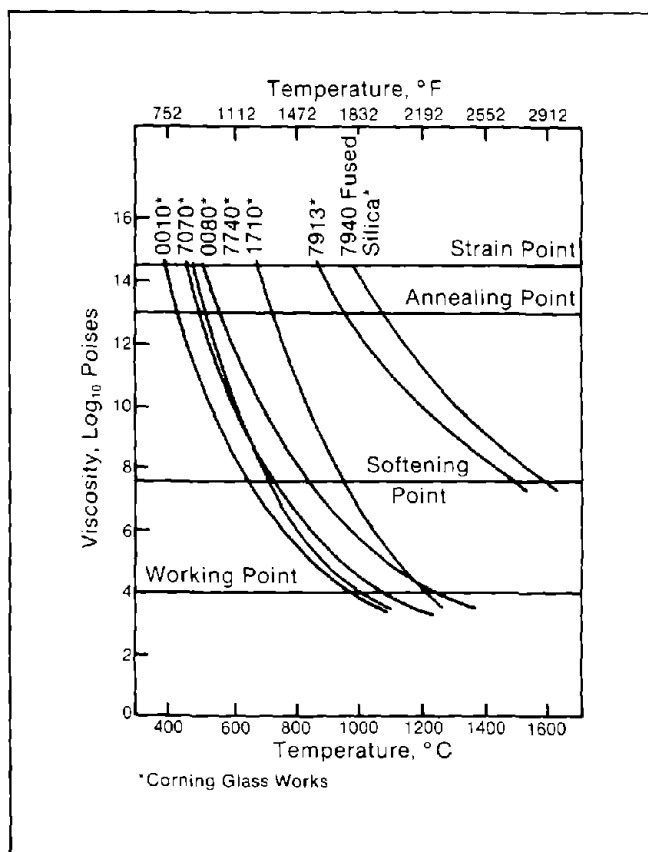
Figure 2-4 Viscosity - Temperature Curves (CIT 1978)

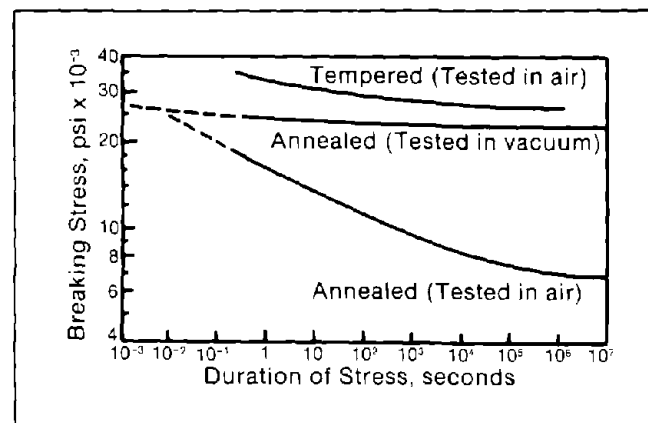
Figure 2-5 Stress Time Characteristics of Glass (Bouquet 1979)

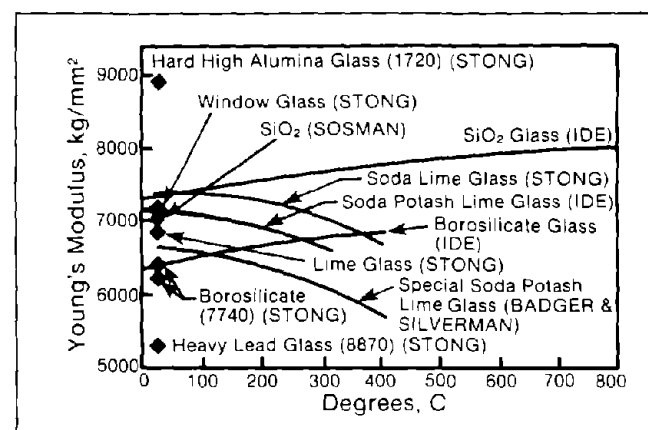
Figure 2-6 Young's Modulus of Various Glasses (Bouquet 1979)

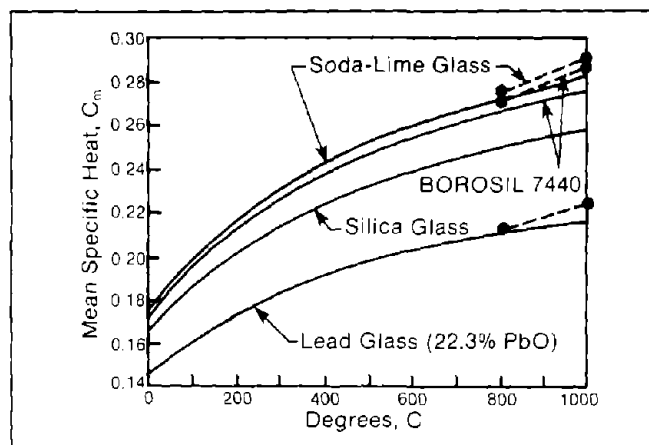
Figure 2-7 Mean Specific Heat of Glasses (Bouquet 1979)

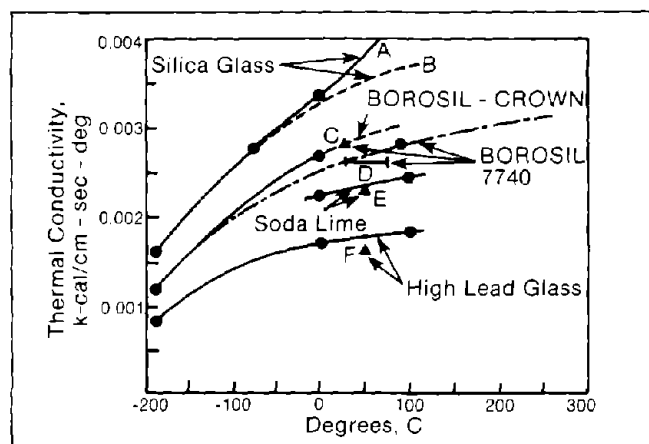
Figure 2-8 Thermal Conductivity of Glasses (Bouquet 1979)

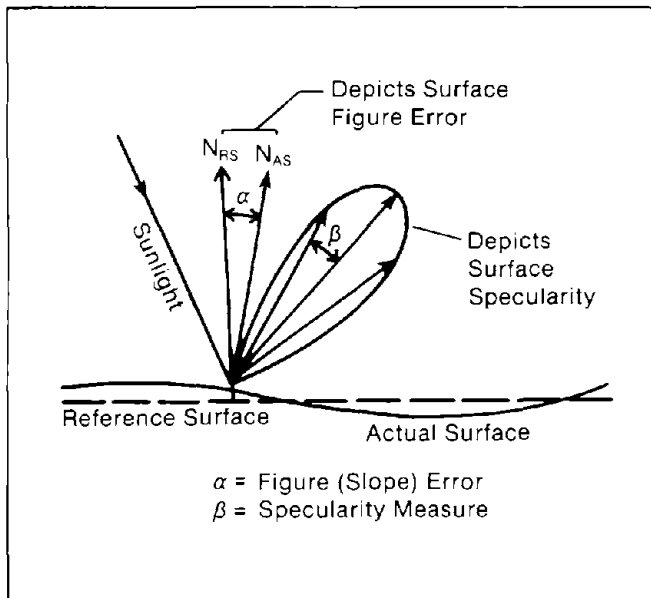
**Figure 2-9 Schematic Representation of a Mirror Surface Showing the Difference Between Figure (Slope) Errors and the Mirror Specularity** (Pettit and Roth 1980)

Two measures of surface irregularities that cause loss of redirected sunlight from a solar mirror are surface specularity and surface figure error. Specularity measures the scattering from surface variations with a characteristic spacing of less than approximately 1 mm, whereas scattering from surface contour (slope) variations on a scale greater than approximately 10 mm is referred to as the surface figure error.

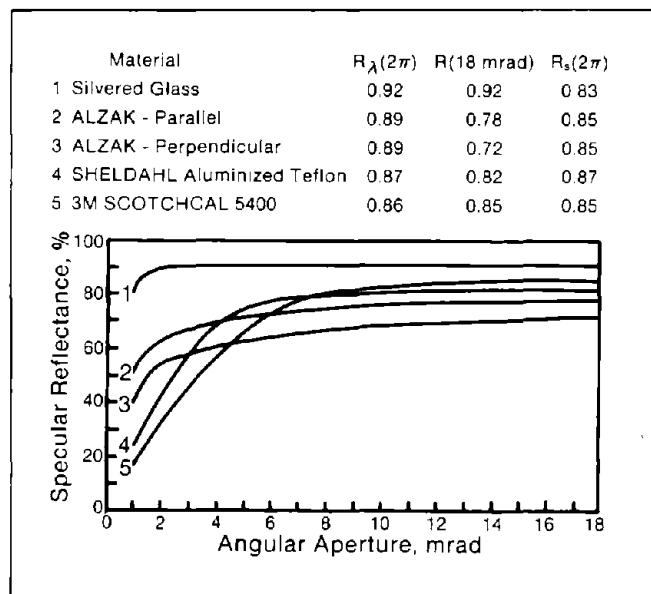
**Figure 2-10 Specular Reflectance Properties for Several Solar Mirror Materials.** The table lists the hemispherical reflectance  $[R_\lambda(2\pi)]$  and the specular reflectance at 18 mrad  $[R(18 \text{ mrad})]$  measured at 500 nm. Also listed is the solar-weighted hemispherical reflectance  $[R_s(2\pi)]$  (Pettit and Roth 1980)

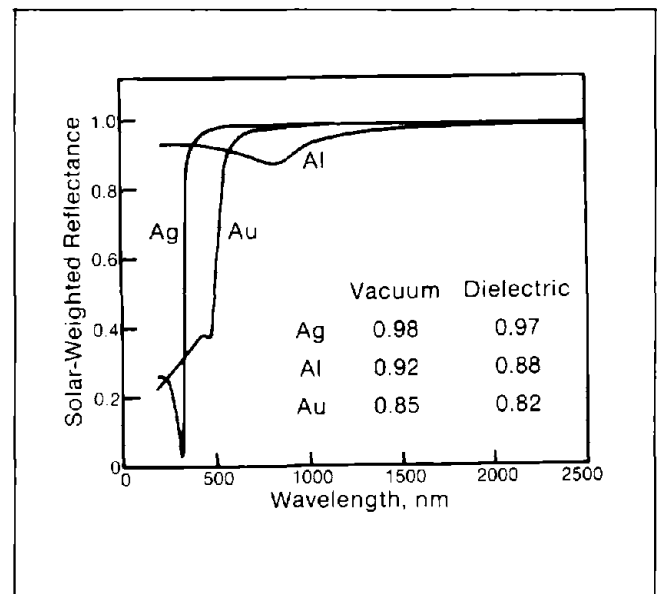
**Figure 2-11 Reflectance Properties of Silver (Ag), Aluminum (Al), and Gold (Au) as a Function of Wavelength for the Metal/Vacuum Interface.** The table lists the solar-weighted reflectance for a metal/vacuum interface and a metal/dielectric interface with an assumed index of refraction of 1.5. (Pettit and Roth 1980)

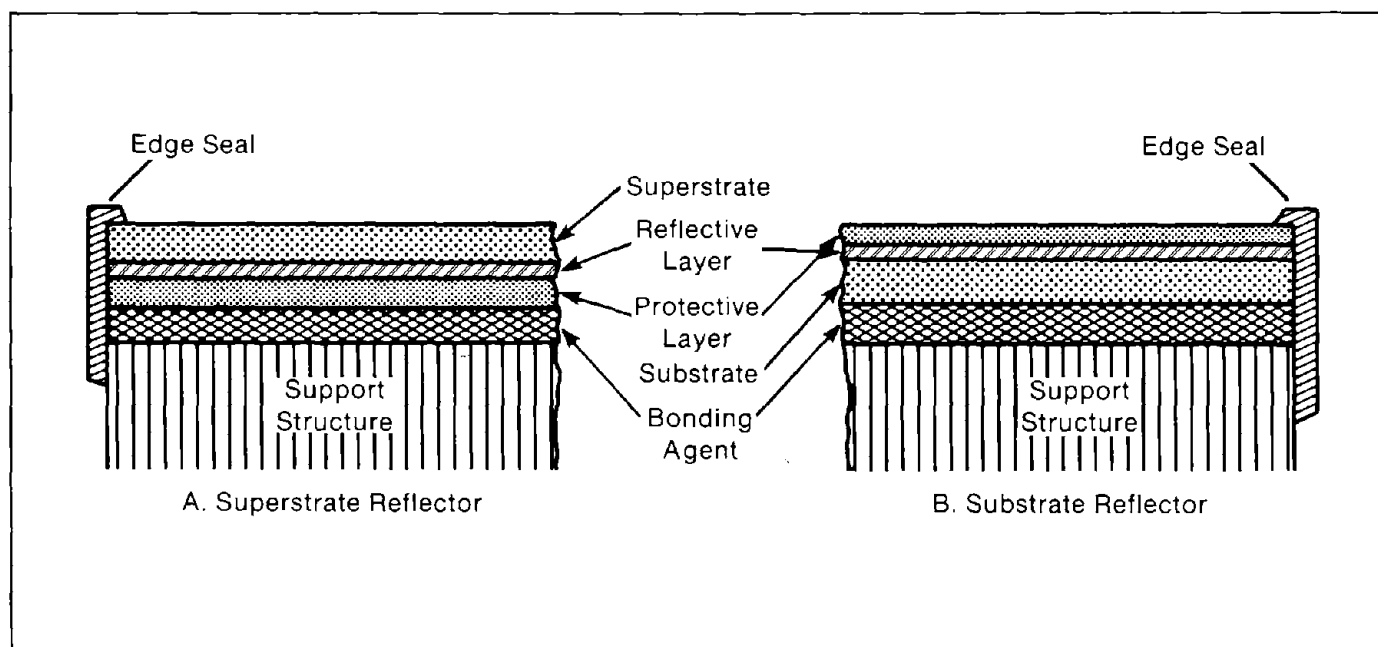
Figure 2-12 Examples of Typical Reflective Surfaces (Bouquet 1980)

The chemical and physical processes involved in the preparation and degradation of silver/glass mirrors are discussed in this chapter. As illustrated in Figure 2-12 (superstrate) in Chapter 2, the silver/glass mirror consists of a multilayer stack of glass, silver, and a protective backing. The protective backing may also consist of two or more multilayers. The most important stability issues for a multilayer configuration are interface reactions, adhesion, and the choice of the protective backing. In the descriptions of possible causes of mirror degradation in this chapter, reference is made to various analytical techniques to discern the causes. A brief description of the purpose of the techniques is contained in Table 3-1.

The life-cycle cost of a particular mirror design depends on the durability of the reflector assembly, such as shown in Figure 2-12 in Chapter 2. The purpose of sandwiching the reflective material into a multilayer stack is to limit reactive constituents from reaching the silver; thus, increasing the performance lifetime of the mirror. Mirror durability, therefore, depends on the materials used to form the multilayers and the environmental exposure parameters. The degradation problems associated with multilayer stacks clearly depend on the ability of the glass and protective backing to exclude reactive materials, the ability of the manufacturer to exclude reactive impurities during manufacture, and the rate of interfacial processes connected with the materials used; e.g., interdiffusion and ion exchange.

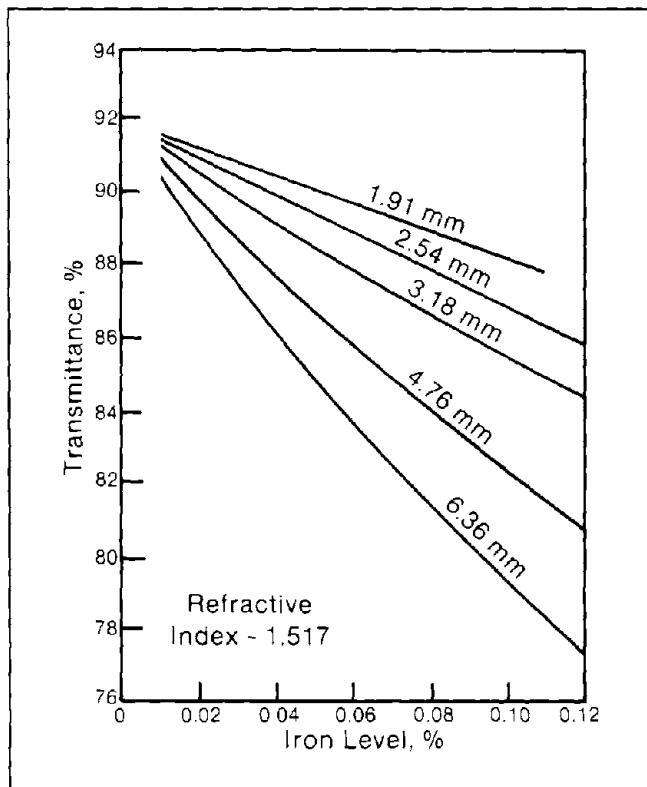
**Figure 2-13 Solar Transmittance as a Function of Iron Content and Glass Thickness (Bouquet 1979)**

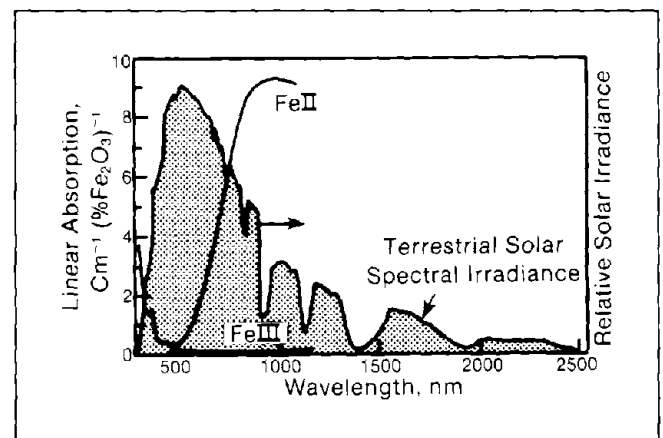
**Figure 2-14 Absorption Coefficients of Fe<sup>+2</sup> and Fe<sup>+3</sup> in Soda-Lime Glass** (The shaded curve is the relative spectral solar irradiance) (Coyle 1981)

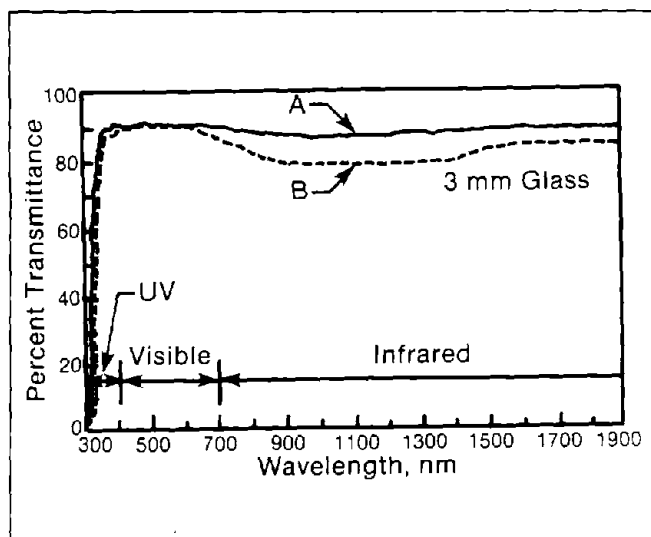
Figure 2-15 Transmittance for Low-Iron, 3-mm Glass (A) and Normal 3-mm Glass (B) (Goodyear 1980)

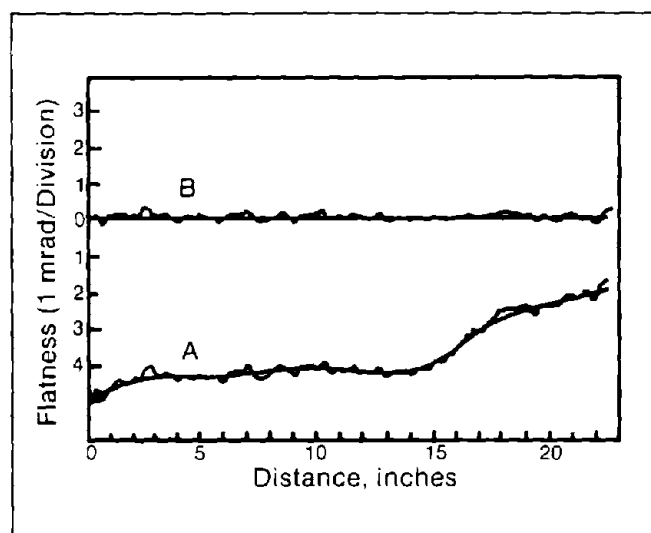
Figure 2-16 Flatness of 3-mm Glass as Measured by Laser Scan at Battelle Pacific Northwest Laboratories. (Glass for Curve A is not corrected for bow; that for Curve B is corrected for bow.) (Goodyear 1980)

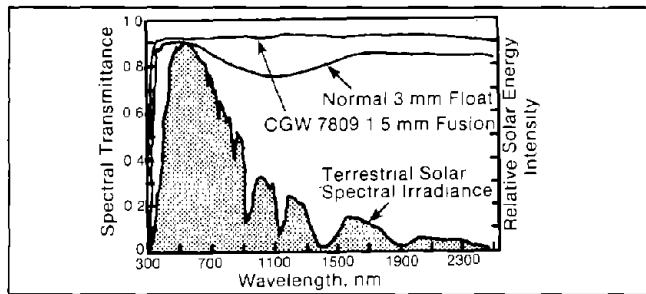
Figure 2-17 Transmittance in Solar Spectrum of CGW-7809 Fusion and Soda-Lime Glass (Coyle and Livingston 1981)

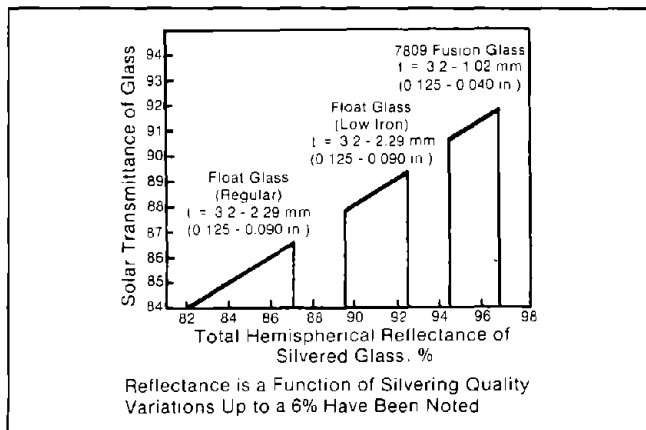
Figure 2-18 Solar Reflectance of Second-Surface Silvered Mirrors on Different Glasses (Coyle and Livingston 1981)

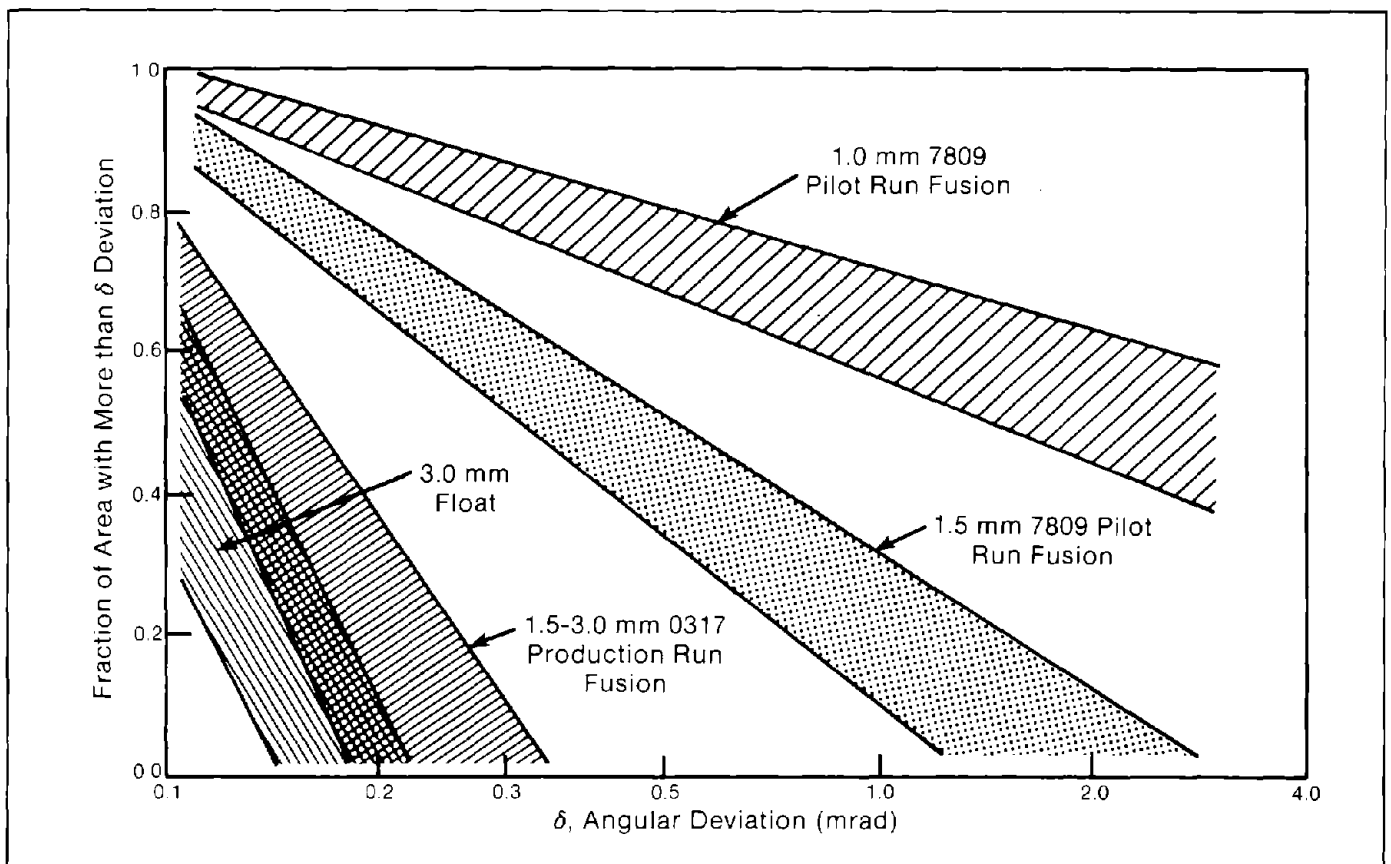
Figure 2-19 Fraction of Glass Surface Area with More than Angular Deviation from Specular Reflection (Coyle and Livingston 1981)

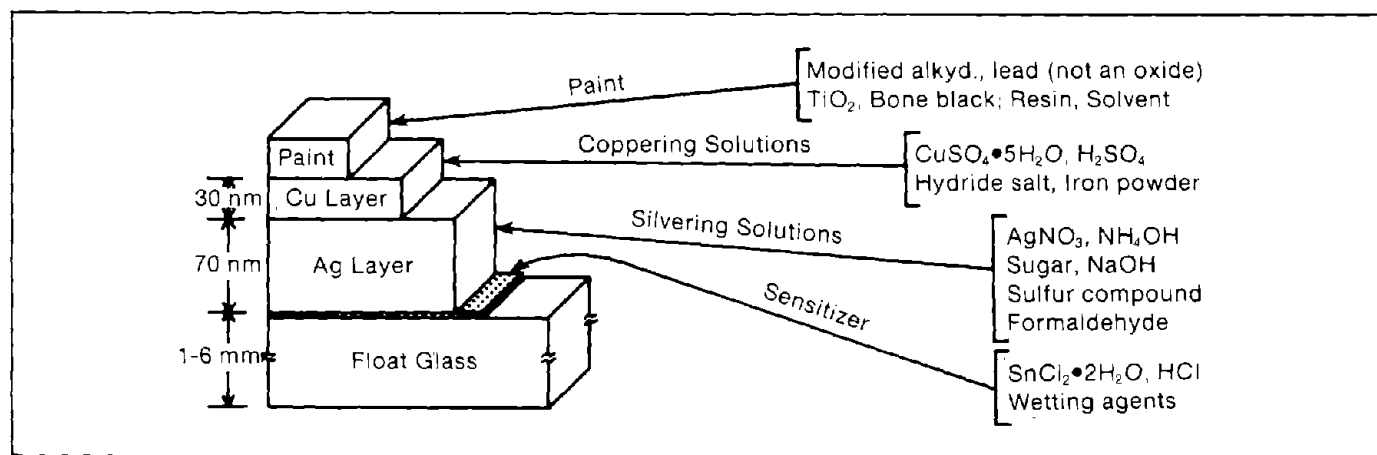
The chemical components that are used to sensitize glass, to deposit silver and copper, and that are in a commercially used paint are shown in Figure 3-1, along with typical thicknesses of the various layers. The covalently bonded superstrate is in contact with the metallically bonded silver and copper layers, and these are bonded to the paint-backing layer. This section first considers the physics and chemistry involved in the step-by-step preparation of a mirror, then discusses the degradation reactions that occur or might occur at the various interfaces, and finally discusses the properties of both freshly prepared and degraded mirrors. Some recent research results will be appropriately included in each subsection.

Figure 3-1 Morphology and Chemical Components Used in a Typical Commercial Mirror (Thomas 1983) [Not to scale]

The components in the paint (Figure 3-1) appear relatively inert, but surface analysis data revealed that Cl and S are also present, as shown in Figure 3-5. The

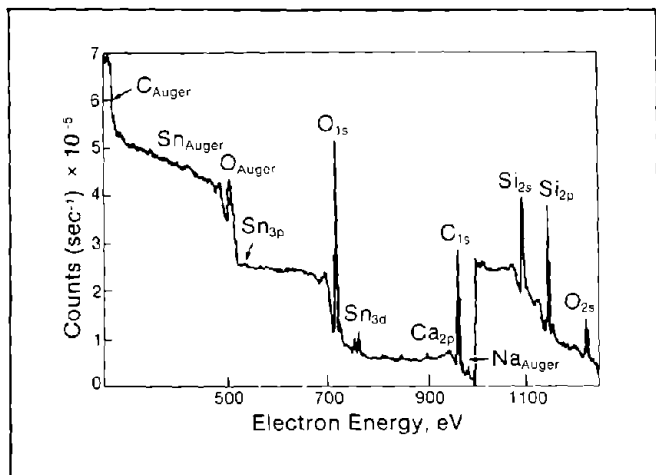
Figure 3-2 ESCA Survey of the Unspattered Air Surface of the Soda-Lime Silicate Float Glass (Pederson and Thomas 1980)

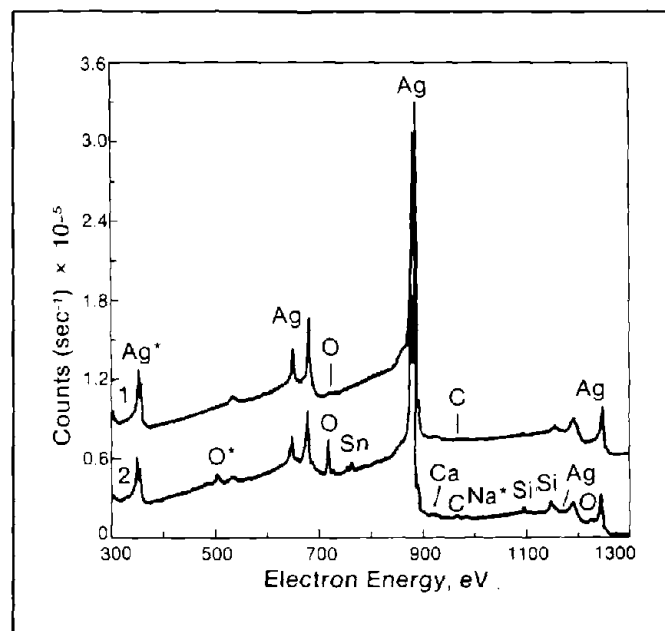
Figure 3-3 XPS Survey Scan of the Elements Present in the Bulk of the Silver Layer (spectrum 1). XPS Survey Scan of the Elements Present in the Silver/Glass Interface Region (spectrum 2). The asterisk indicates Auger signal (Thomas 1983)

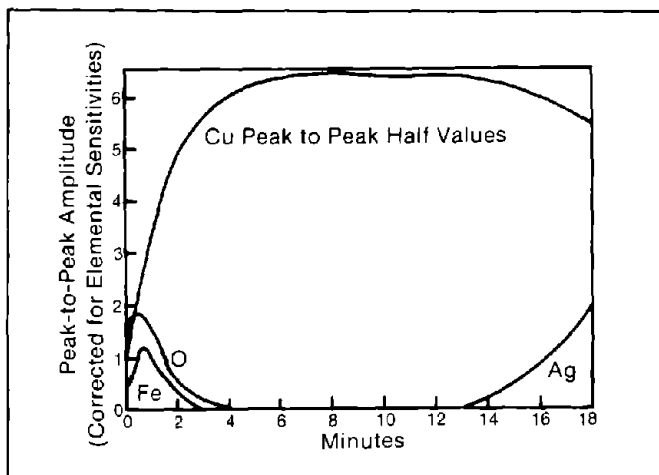
**Figure 3-4a Auger Electron Depth Profile Through the Copper Layer of a One Year Old Mirror after Removal of a Lacquer Backing with Acetone.** The profile has been corrected for elemental sensitivity factors as provided by Physical Electronics (Thomas 1983)

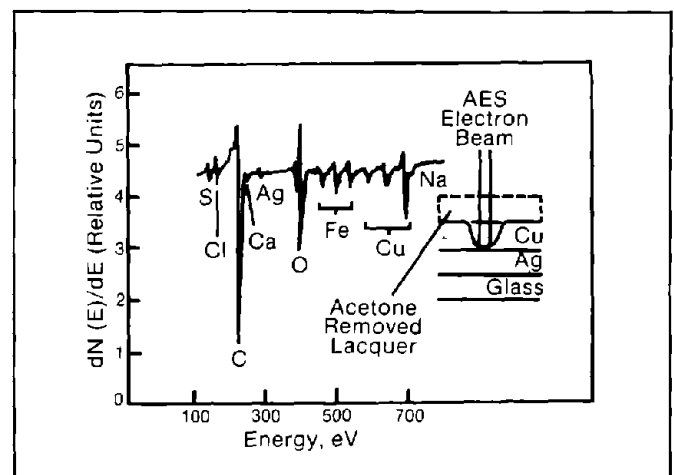
**Figure 3-4b Elements Present on Copper Surface (Zero Time) Shown Using an AES Scan (Thomas 1983)**

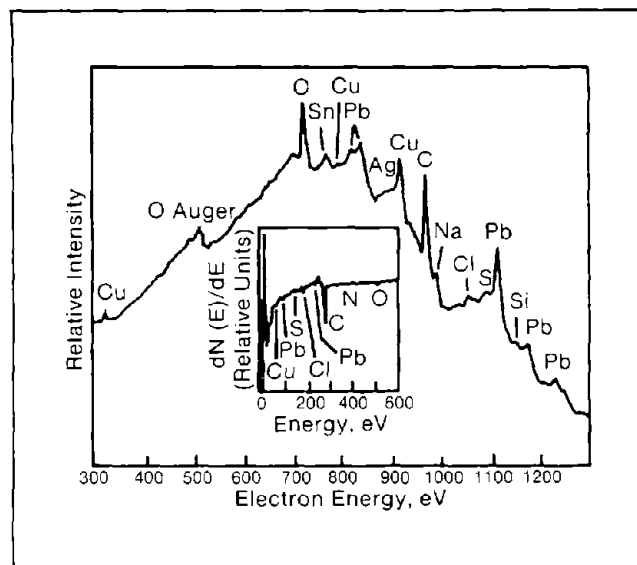
Figure 3-5 XPS Survey Scan of Interfacial Residue on Mirror Paint After Adhesive Failure. Inset is an AES of paint/copper surface (Thomas 1983)

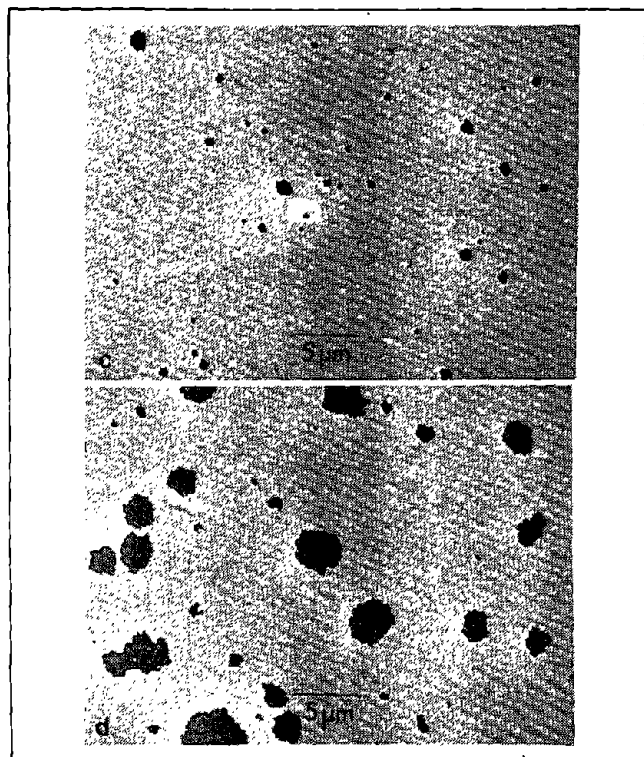
SEM photographs showed that the pinholes enlarge as a function of exposure (Figure 3-6) and that the topographical features are similar to those for corroded heliostat mirrors (Figure 3-7). In accelerated

Figure 3-6 Scanning Electron Micrographs of Silver Films on Float Glass Exposed to 1000 ml of Distilled Water at 90°C (Vitko 1982)

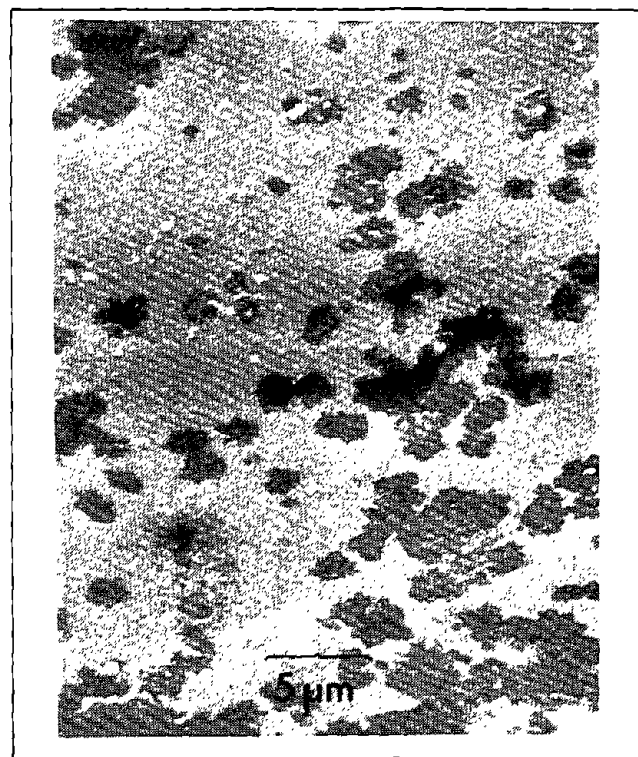
Figure 3-7 Scanning Electron Micrograph of a Field-Corroded Mirror (Vitko 1982)

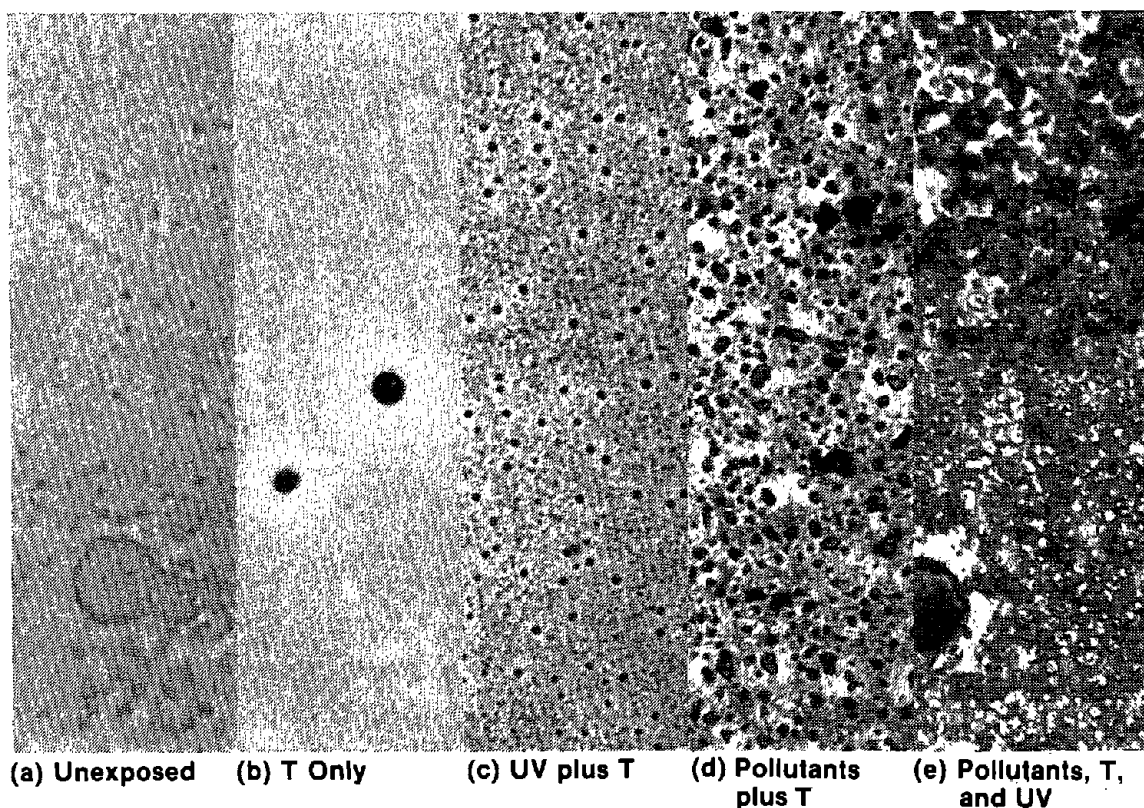
Figure 3-8 Photomicrographs of Undegraded Mirror (a) and After Two Weeks of Exposure to Combinations of T, UV, Pollutants, and Relative Humidity (Gupta 1982)

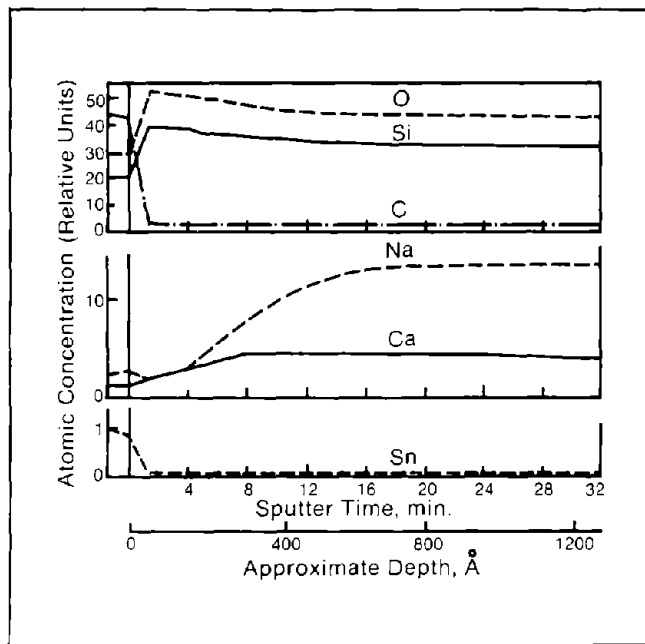
**Figure 3-9 ESCA Depth Profile of the Surface in Figure 3-2 (Pederson and Thomas 1980)**

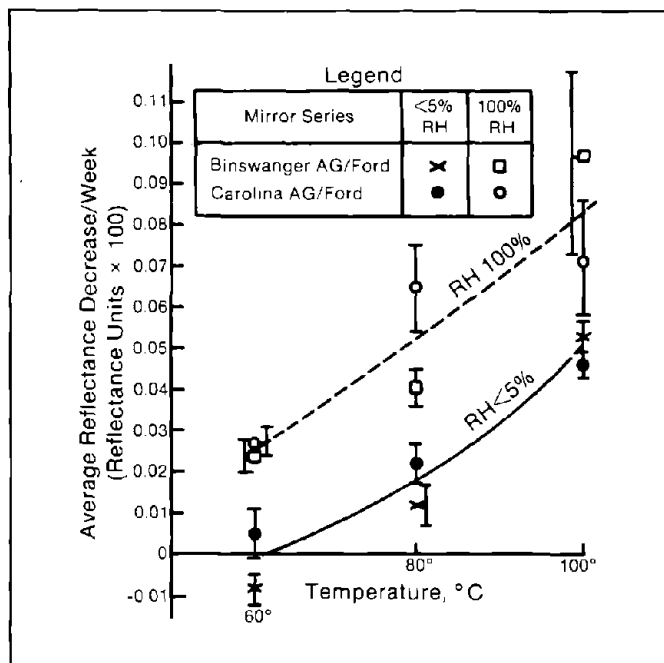
Figure 4-2 Dependence of Degradation in Reflectance on Temperature for High and Low Relative Humidity Using Select, Quality Commercial Mirrors (Masterson 1983b)

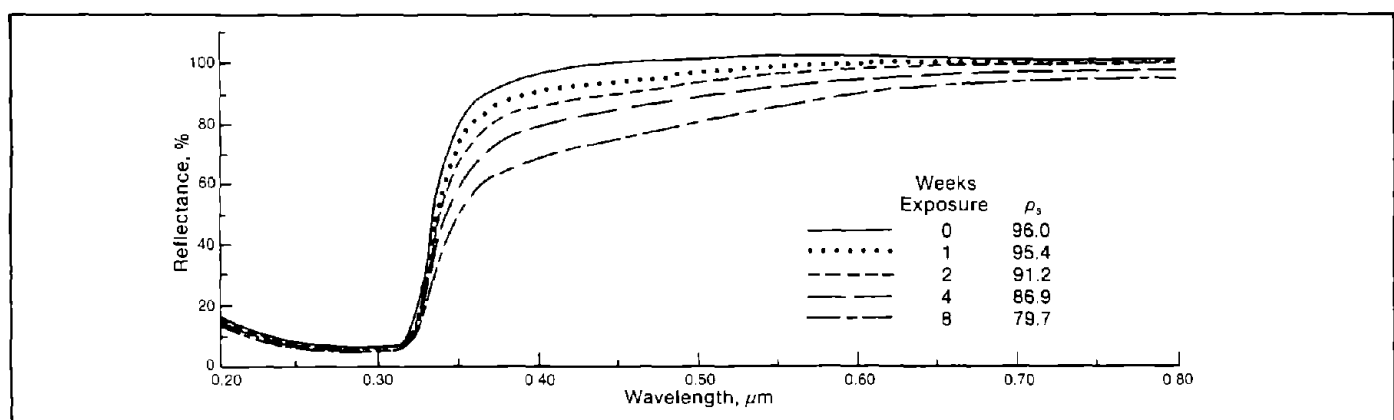
Figure 4-3 Spectral Hemispherical Reflectance for Different Exposures of a Commercial Mirror [Values for the exposure periods and the solar-weighted reflectance ( $\rho_s$ ) are shown in the legend.] (Masterson and Lind 1983a)

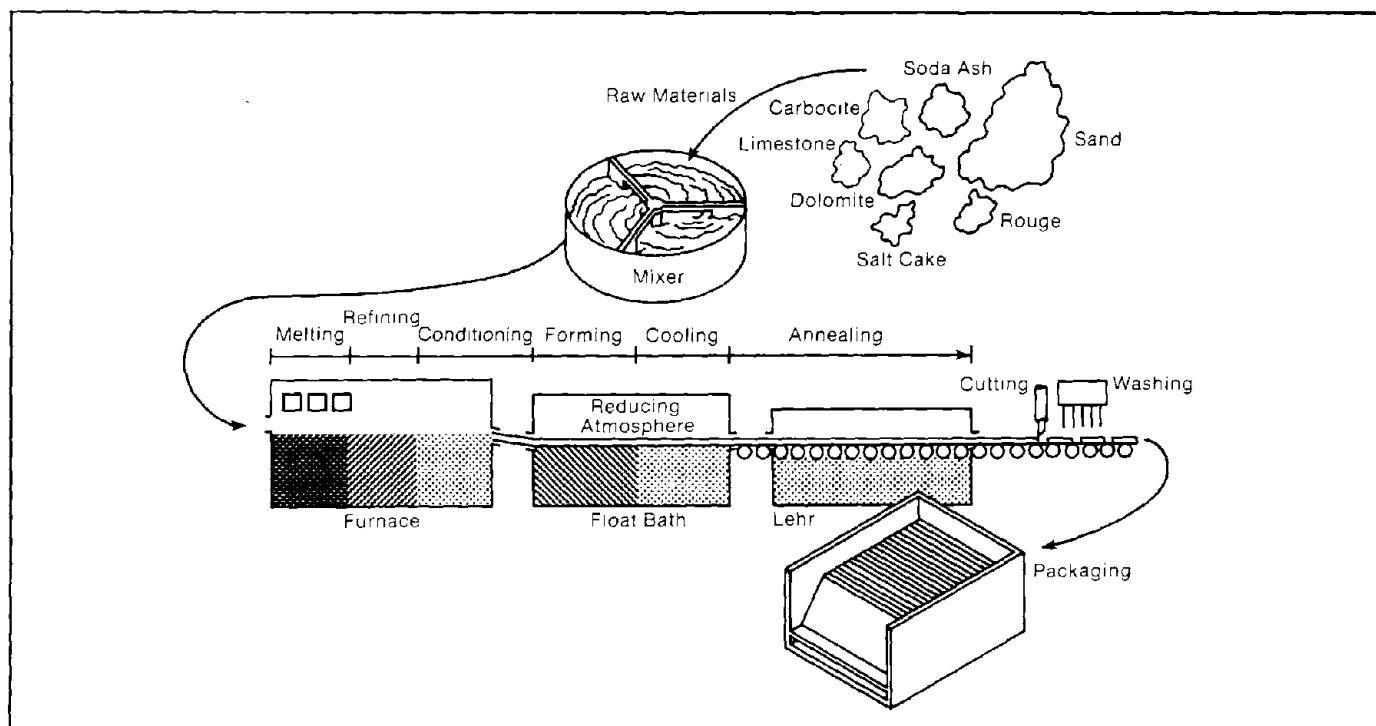
Glass is formed into a sheet by flowing molten glass onto a bath of molten tin. A density differential between the glass and tin results in the glass "floating" on the tin and forming a continuous ribbon of glass with essentially flat, parallel and fire-polished surfaces. The glass ribbon is pulled along the bath of molten tin while simultaneously being cooled to a temperature at which it solidifies. Tin has a lower melting temperature than glass and remains molten throughout the process. A reducing atmosphere is necessary in the forming area to control the oxidation of the molten metal.

Figure 5-1 Schematic Drawing of the Float Glass Manufacturing Process (Lind et al. 1979)

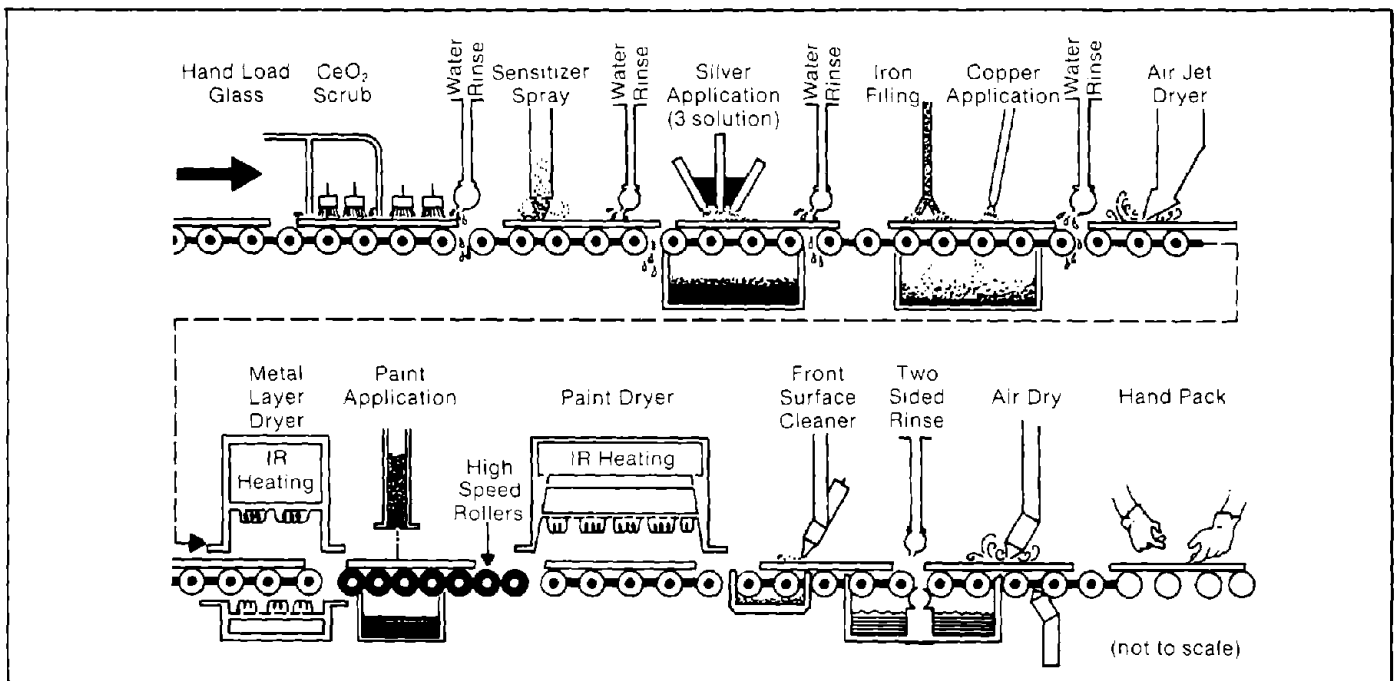
Modern mirroring production lines provide for continuous production and are based on a horizontal-moving conveyor system using turning rollers. Individual glass sheets are fed into the front of the system and no further handling occurs until the finished mirrors are removed from the line output. A typical production sequence is shown schematically in Figure 5-2. The primary steps are indicated in sequence from left to right.

Figure 5-2 Wet-Chemistry Mirror Production Sequence (Lind et al. 1979)

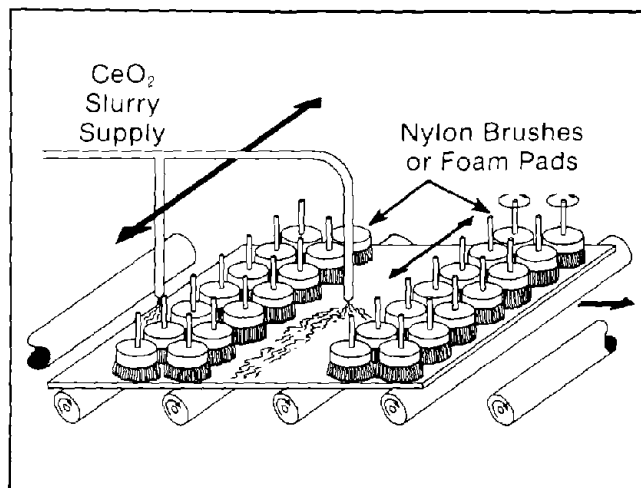
A typical glass-scrubbing unit is shown in Figure 5-3. The scrubber employs an abrasive slurry applied to the glass by small flow nozzles that move across the conveyor line transverse to the direction of glass motion. The transverse speed is coupled to the conveyor line speed to ensure that the surface is adequately cleaned. Cerium oxide slurry is the most commonly used abrasive. Wetting agents are generally added to the slurry to improve cleaning. Surface abrasion is accomplished by rotating brushes or pads that actually scrub the surface. The rotating brush assemblies oscillate back and forth across the glass to provide uniform cleaning. Municipal-grade water is used as the carrier for the abrasive slurry.

**Figure 5-3 Abrasive Glass-Scrubber Using Continuous Slurry Application and Oscillating Assemblies of Rotating Brushes** (Lind et al. 1979)

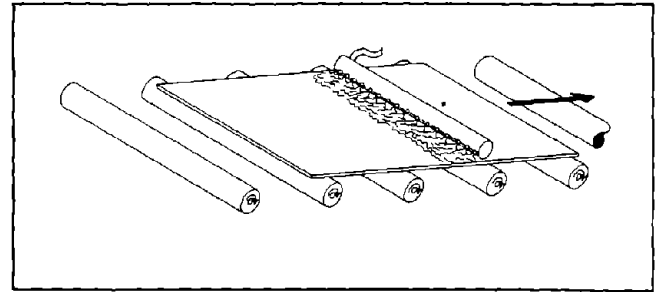
**Figure 5-4 Water-Rinse Mechanism Using Directed Water Spray to Rinse Process Residuals Off Rear Edge of Glass** (Lind et al. 1979)

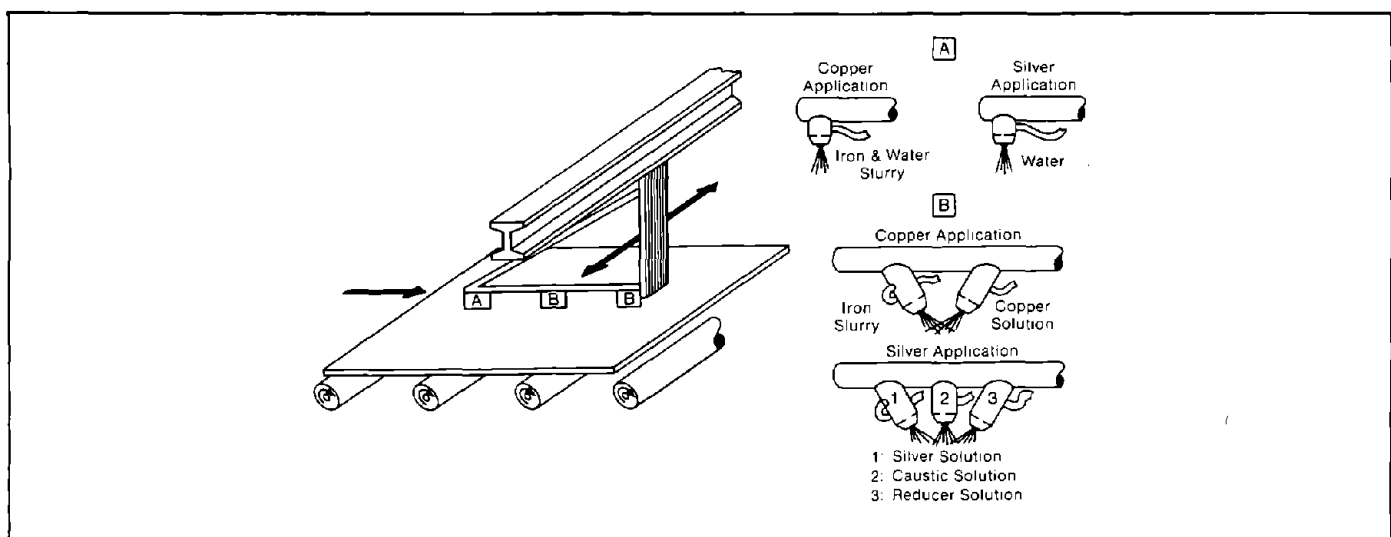
**Figure 5-5 Reciprocating Spray Chemical-Applicator for Wet-Chemistry Mirroring Solutions.** Specific nozzle arrangements are shown for a galvanic copper and a three-part silver process. The details A and B (on right) represent the nozzles placed at A and B on left of illustration. (Lind et al. 1979)

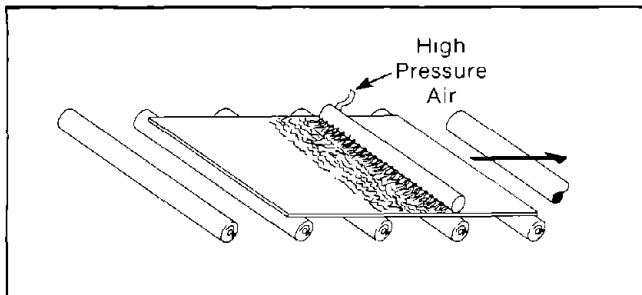
**Figure 5-6 Air-Jet Drying Station Using Directed Air Flow to Force Process Residuals Off Back Edge of Moving Glass Sheet (Lind et al. 1979)**

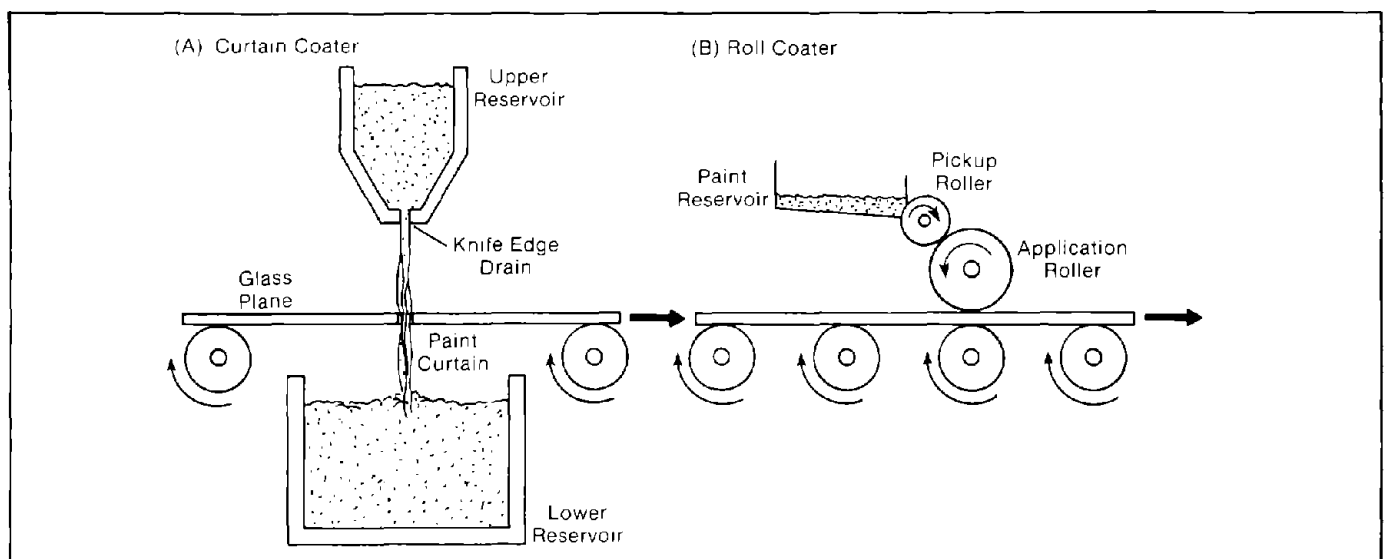
**Figure 5-7 Cross-Section View of Two Types of Paint Applicators (Lind et al. 1979)**

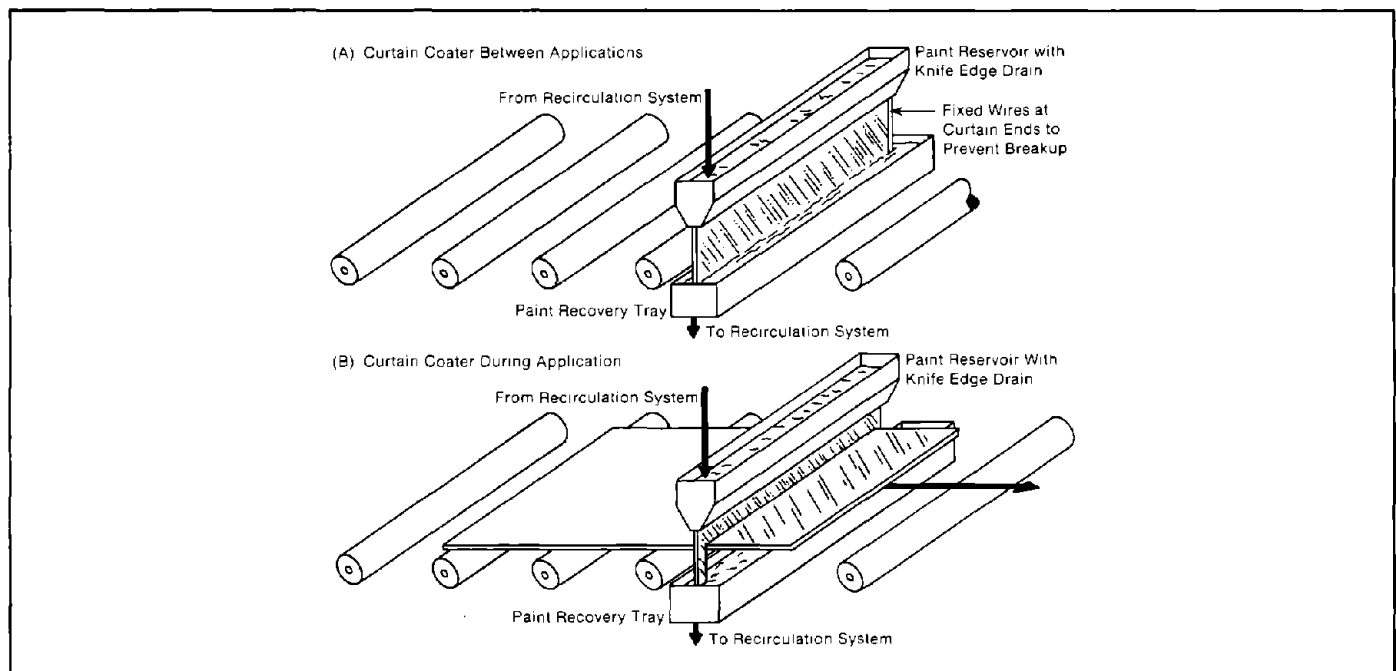
**Figure 5-8 Curtain-Coater Operation: (A) Between Applications, and (B) During Application (Lind et al. 1979)**

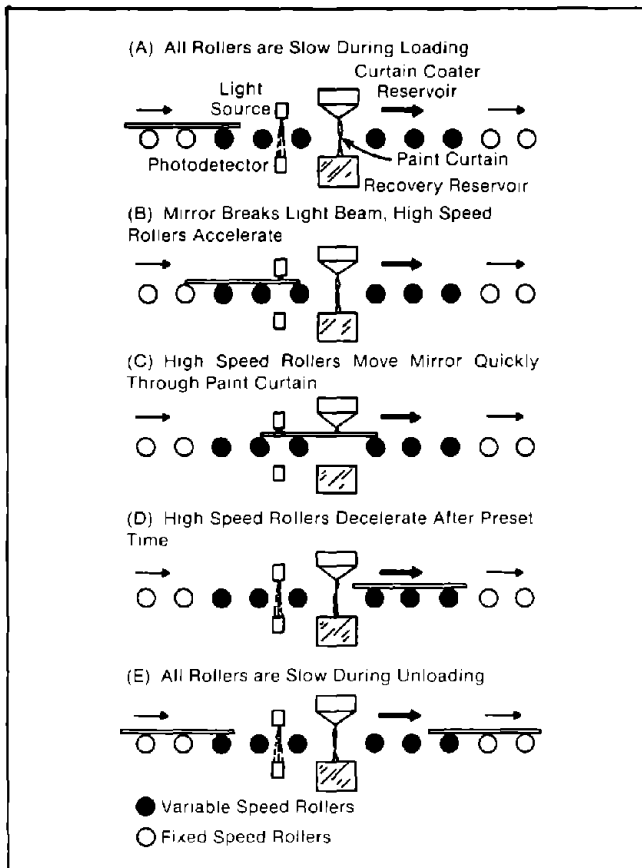
**Figure 5-9 Production Sequence for Variable-Speed Roller Section Associated with Curtain-Coater Operation (Lind et al. 1979)**
