# Silver/Glass Mirrors for Solar Thermal Systems

SERI/SP-271-2293

June 1985

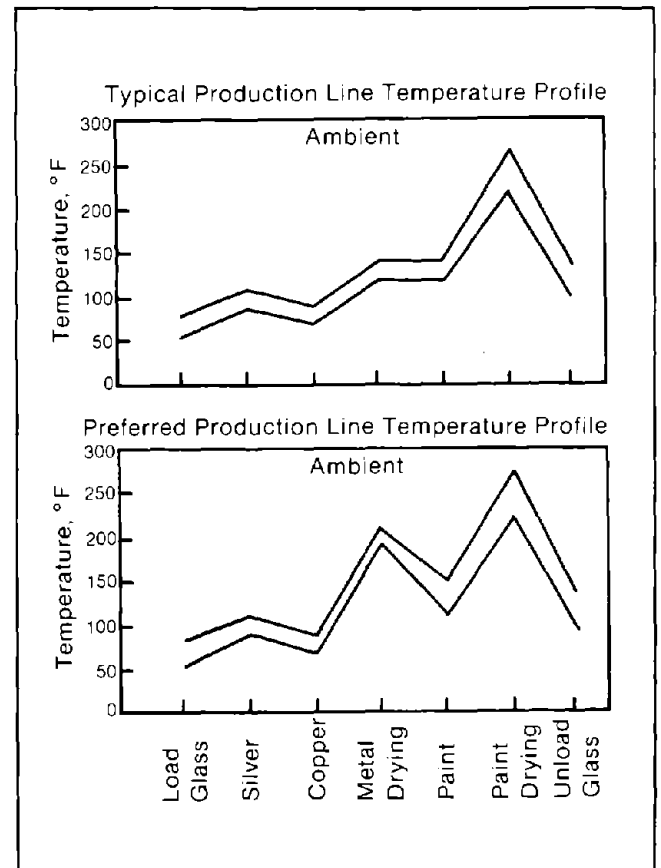
**Figure 5-10 Production-Line Temperature Profiles (Lind et al. 1979)**
